Multiscale analysis of gully erosion in Palmital stream watershed, Minas Gerais (Brazil)

Ádria Kanome Mori Soares

ABSTRACT: Gully erosion can lead to irreversible financial and soil losses, which endorse a detailed study of erosive processes and their conditioning factors in each degraded area. However, studies on a multiscale analysis are relatively lacking. Hence, this study sets out to show how to use an integrated and multiscale approach to assess gully erosion in one gully from the Palmital stream watershed, in Nazareno and Conceição da Barra de Minas (Minas Gerais, Brazil). In the watershed scale (1:50,000), we made anaglyphs and mapped the gullies from 2016 and 2019. In the gully scale (1:5,000), an image of the gully was obtained with a remotely piloted aircraft (RPA). They were analyzed to verify the erosion process and to perform fractal analysis. We also collected soil samples for physical and chemical analysis. Results showed connections between gullies and that the erosive process is still active, occurring on different scales inside the gully, including as tubular erosion in the Cambisol, which destabilizes the Oxisol, enlarging the gully head. Fractal analysis resu

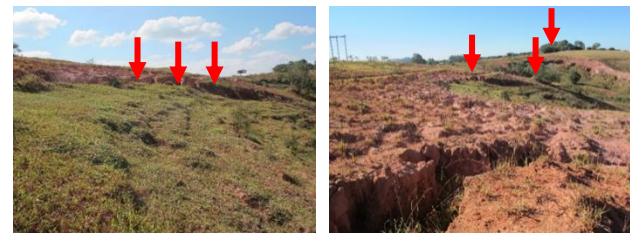
Figure 7. Part of the gully head: highlights for the “stair” formation on the ground.

Subterranean flow played a major role in the evolution of the gully erosion process, since it removed Cambisol from underneath the more stable red-yellow Oxisol, creating empty subsurface spaces that collapsed, since Cambisols were exposed. An almost hollow “stair” formation (soil subsidence) is observed in the ground (Figure 7) and subsurface erosion is predominant in the gully head (Figure 10).

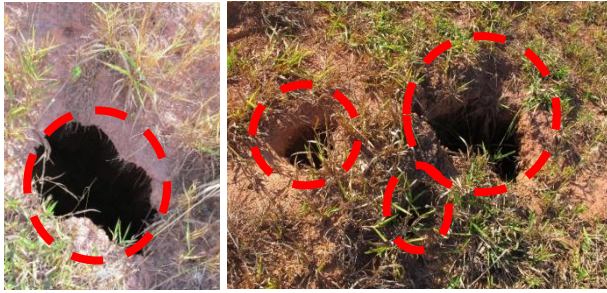
Figure 10. Examples of subsurface erosion over the gully head.

According to Figure 10, subterranean erosion occurs in the soil, i.e., the soil erosion mechanism begins inside the gully walls,

removing more fragile soil from the slope and letting more resistant soil be exposed to more weathering conditions (differently from the conditions experienced when the soil is exposed), thus increasing its fragility and causing slides.

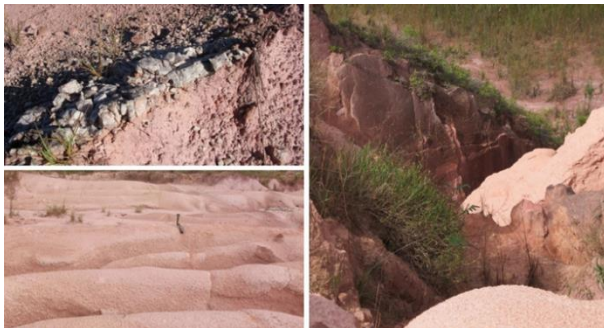
The laboratory results (Table 2) and field study (Figure 11) showed reminiscent structures and minerals from the rock that formed the soil (orthogneiss and tonalite-trondjemite-granodiorite rocks) e.g., rare earth elements, and that the fault and shear zones also influence the erosion processes in the area. The layer can be considered a weak Cambisol and displays all conditions that worsen subterranean erosion.

Fig. 11 Cambisol inside the gully erosion. Upper left: reminiscent rock structure; lower left: crack following fault direction on soil; right: possible rock structure among Cambisol.
