**Investigation of the gen presence and formation of biofilms by *Staphylococcus* in a milk processing micro-dairy** - Santos S.S.<sup>1</sup>, Medeiros M.I.M.<sup>1</sup>, Souza V.<sup>1</sup>, Melo P.C.<sup>1</sup>, Zafalon L.F.<sup>2</sup>, Veschi J.L.A.<sup>3\*</sup>, Nader Filho A.<sup>1</sup>

## Investigation of the gen presence and formation of biofilms by *Staphylococcus* in a milk processing micro-dairy

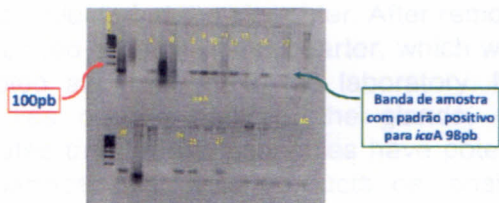
Figure 1 - Gen *icaA* positive in the columns 4, 6, 11, 12, 13, 20 e 24 (tank surfaces); 10 e 27 (pipes); a das columnas 1, 8, 9, 15, 17 e 25 (milk). NC: Negative control.

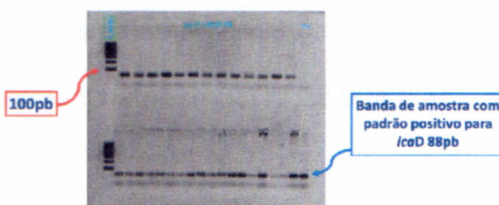
Figure 2 - *Staphylococcus* spp strains / gen *icaD* positive. NC: Negative control.

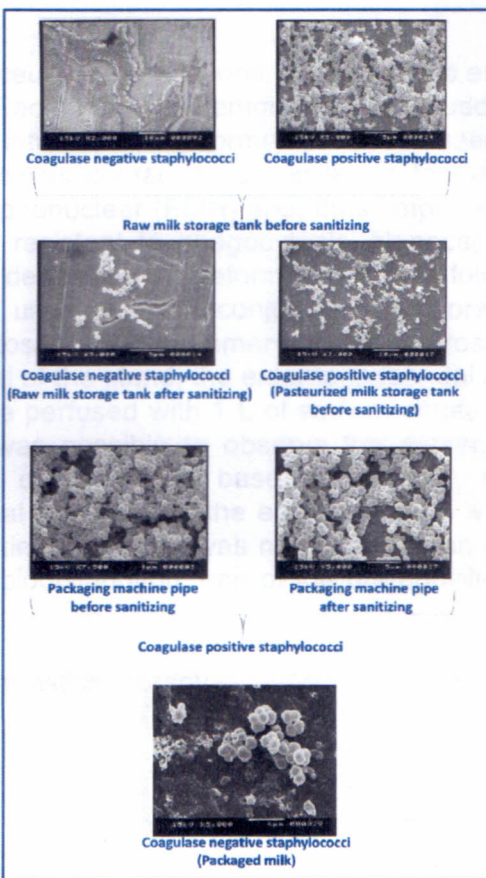
Figure 3B - Micrography of adhered cells of isolated strains on the surface of stainless steel AISI 304
